Upper Mill Meadow Restoration Area

T. 7 S., R. 7 W., Sec. 9

Meadow Site Description – Mary's Peak Resource Area, Salem District BLM

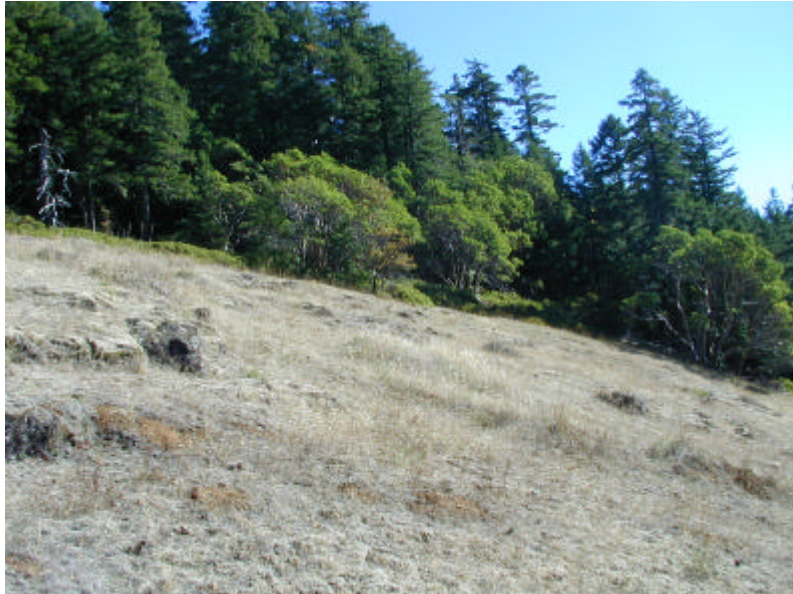
A series of dry meadows, with thin soil. Typically have a fading fringe of oak, and minor levels of conifer invasion.
